**CONSENT ORDER
ISSUED UNDER THE
WATER POLLUTION CONTROL ACT
WEST VIRGINIA CODE, CHAPTER 22, ARTICLE 11**

TO: MarkWest Liberty Midstream & Resources, L.L.C. DATE: March 28, 2019
Gregory Bezdek, SVP, NE Region
4600 J Barry Ct. Ste 500
Canonsburg, PA 15317 ORDER NO.: 8945

MARKWEST LIBERTY MIDSTREAM & RESOURCES, L.L.C, WVR311004, Sherwood to Mobley
20" NGL, 8/22 & 8/23/2018

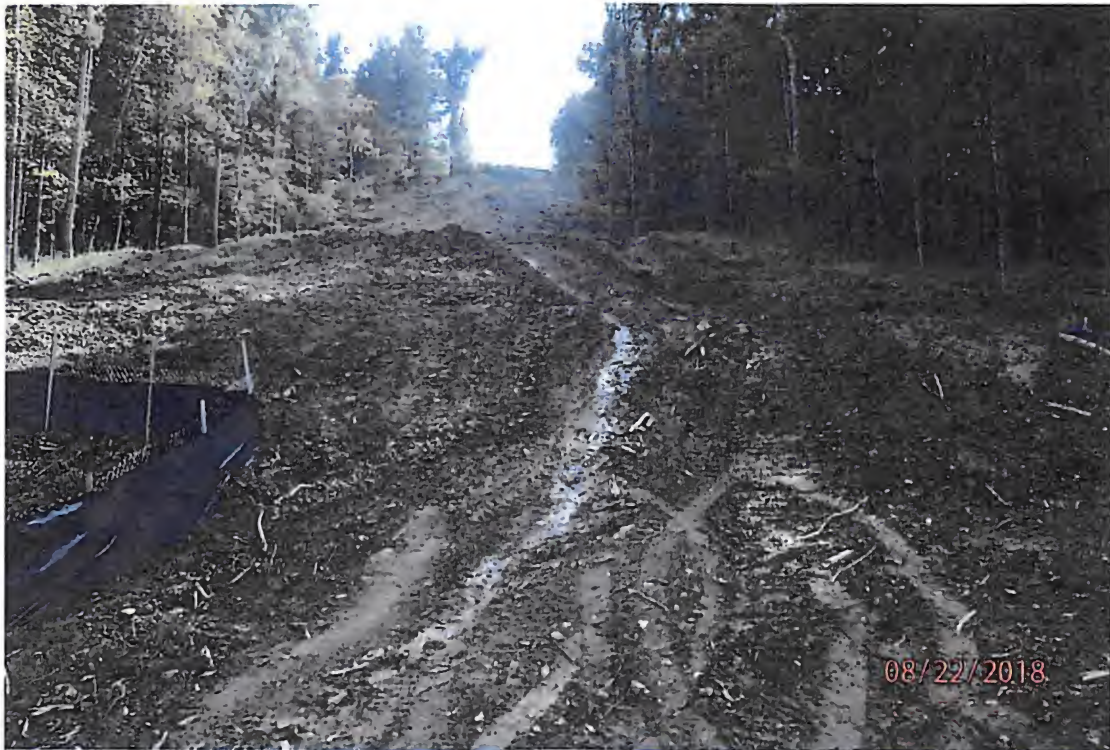
Project area south of the Riggins Run crossing showing a lack of installed water bars.

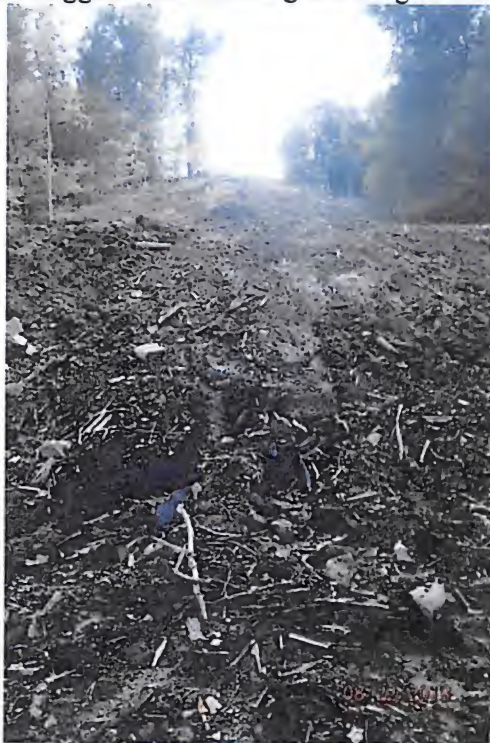
Project area south of the Riggins Run crossing showing erosion gullies as a result of the lack of installed water bars.

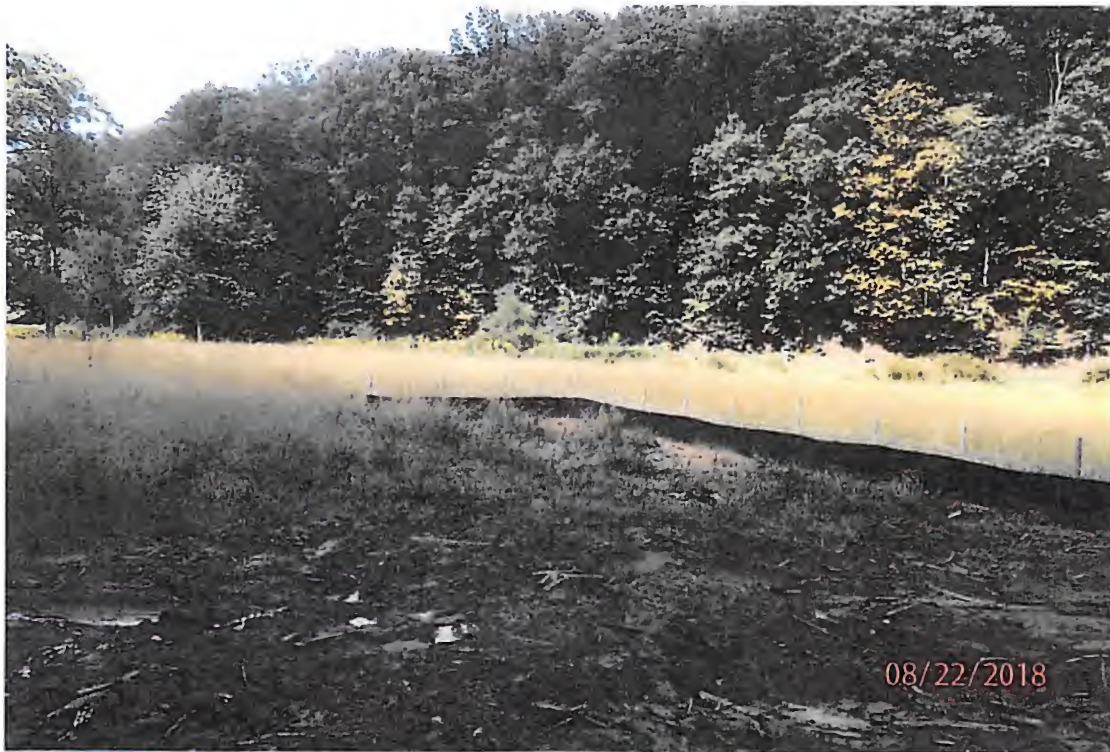
BMP that has been overwhelmed south of the Riggings Run crossing as a result of a lack of installed water bars.

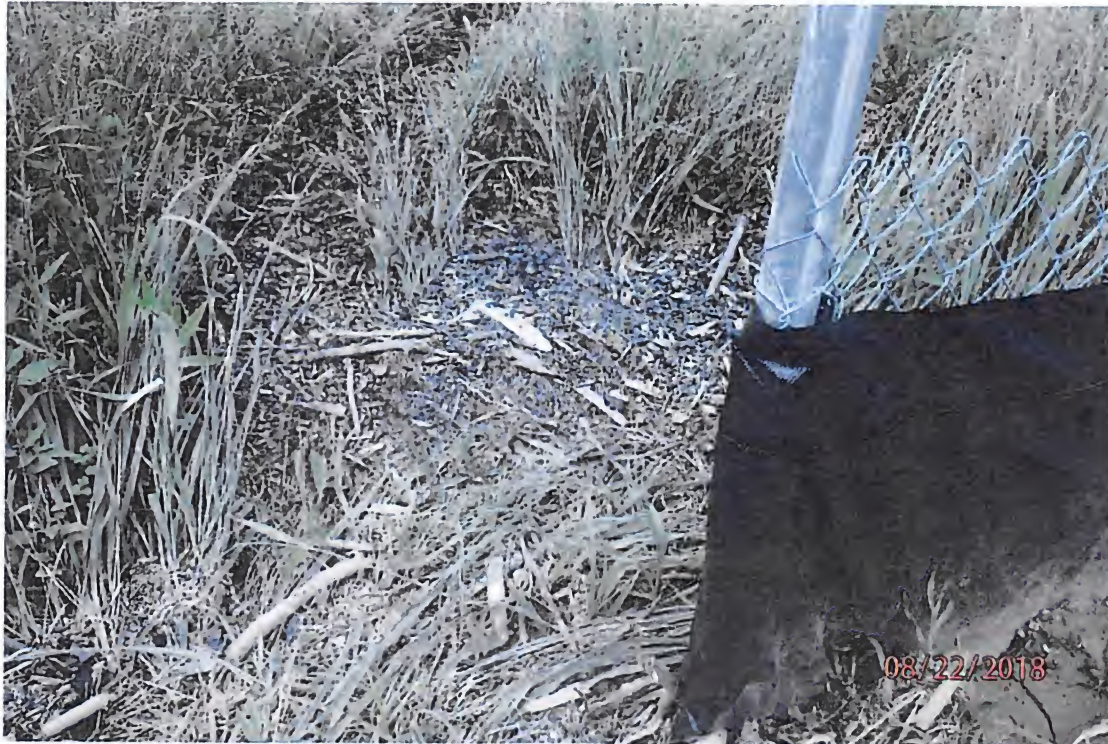
BMP that has been overwhelmed south of the Riggings Run crossing as a result of a lack of installed water bars.

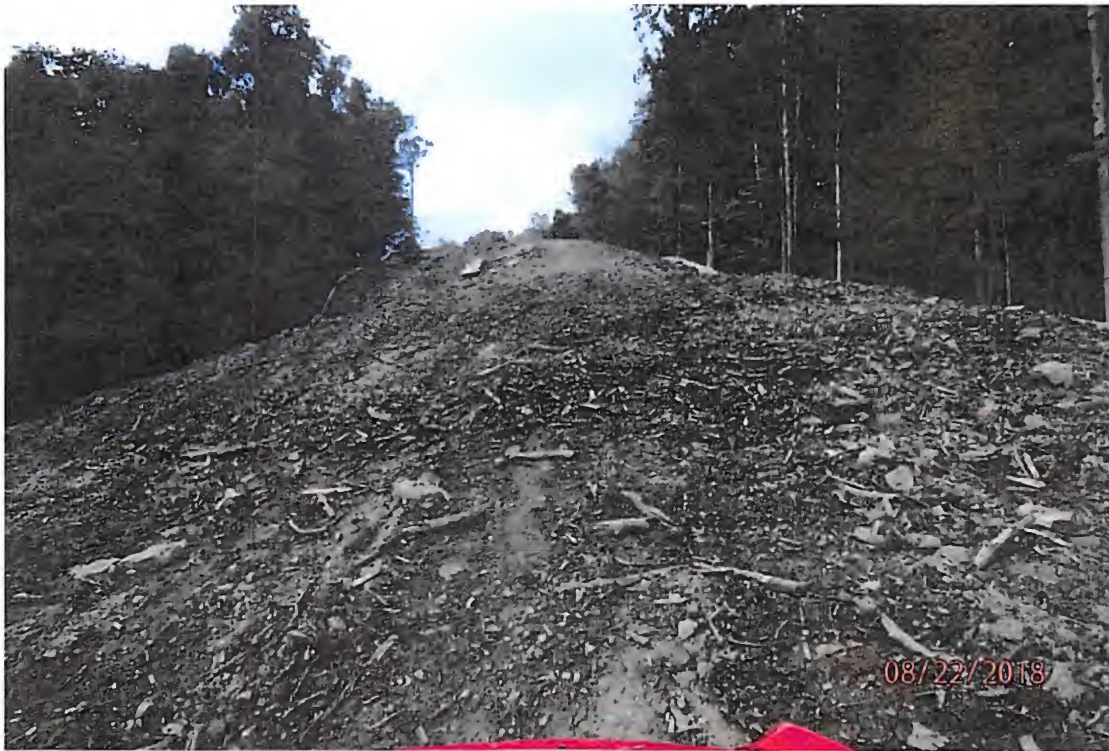
Project area north of the Riggins Run crossing showing a lack of installed water bars.

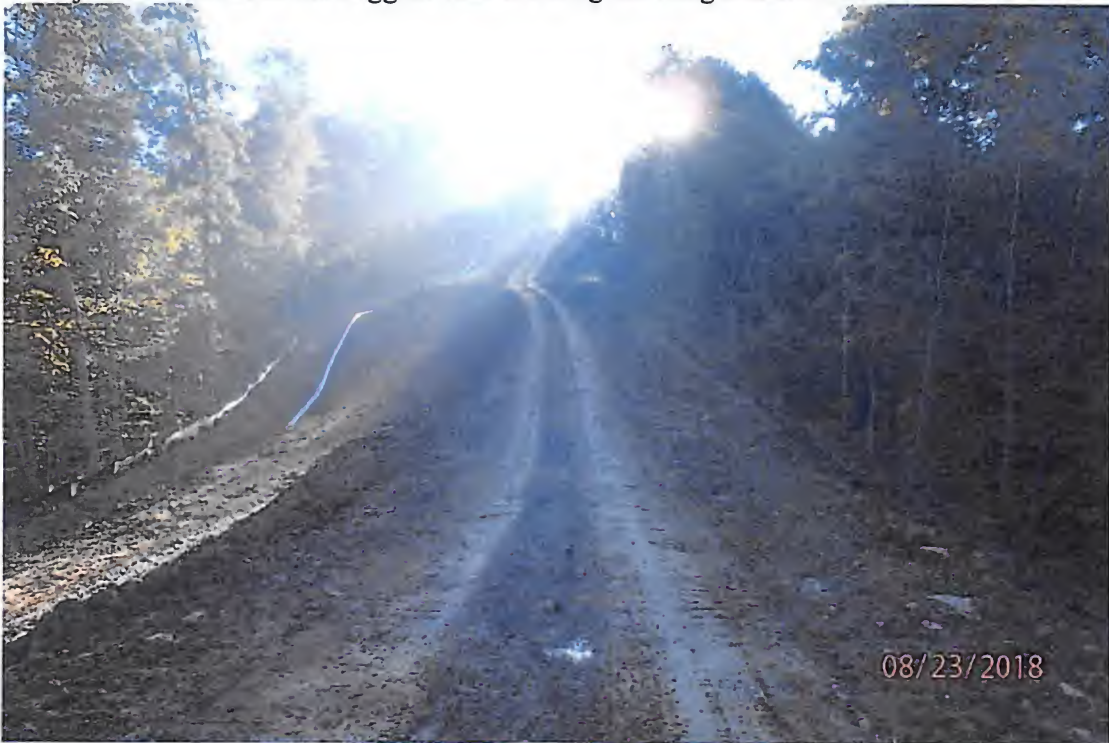
Project area in the Franks Run watershed near 826+00 showing a lack of installed water bars.

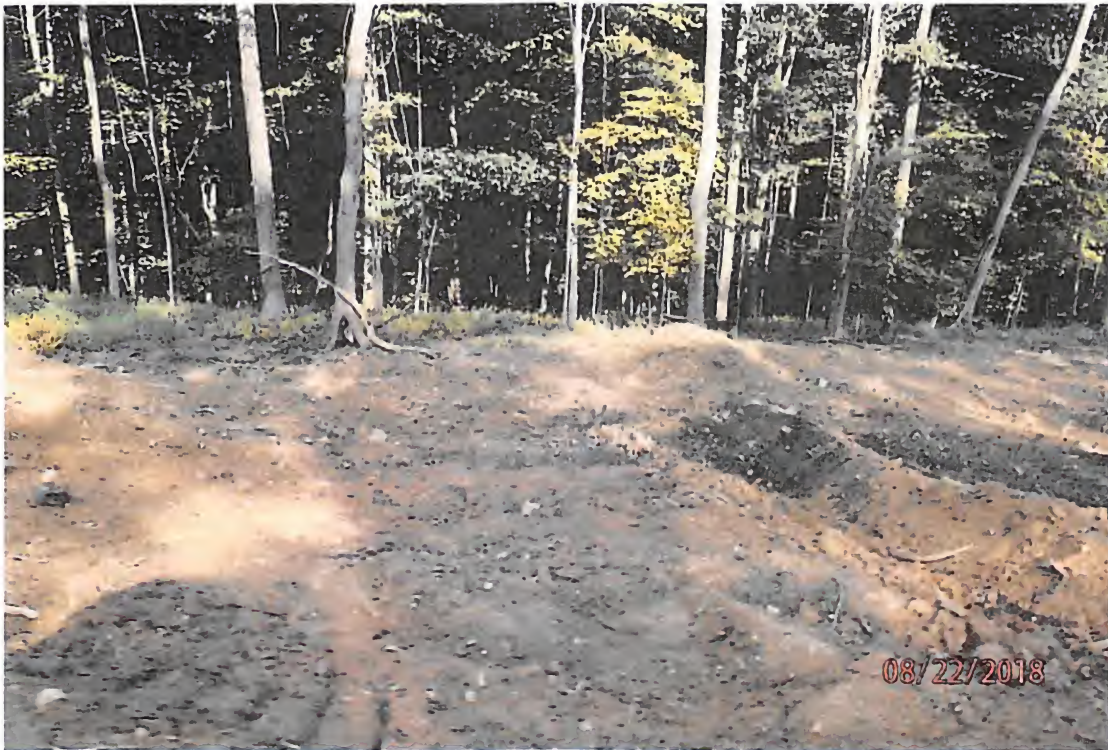
Project area adjacent to 442+00 showing a lack of water bar terminus BMPs.

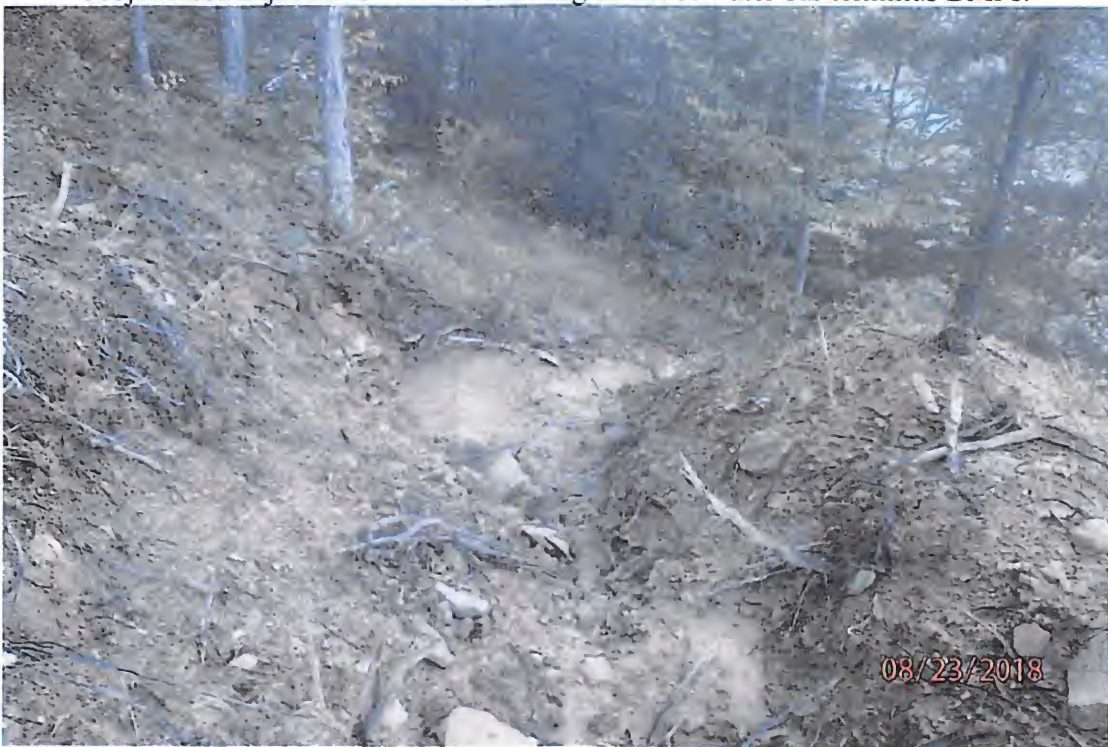
Project area adjacent to 813+50 showing a lack of water bar terminus BMPs.

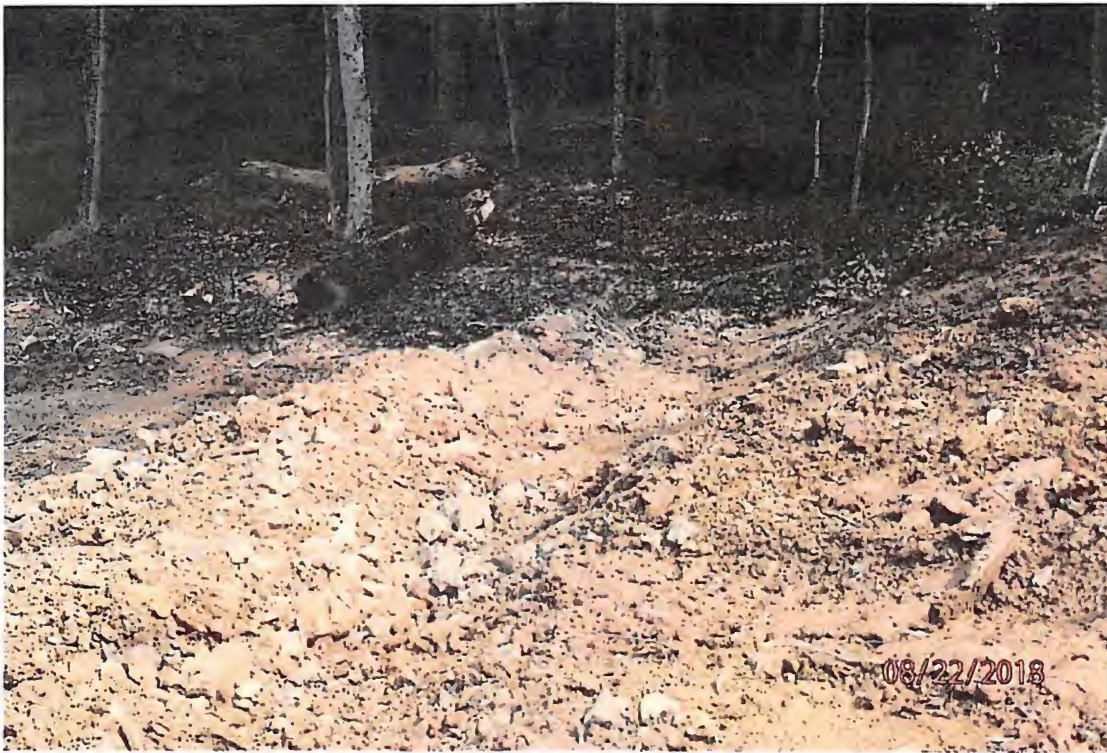
Project area in the Flint Run watershed showing a lack of water bar terminus BMPs.

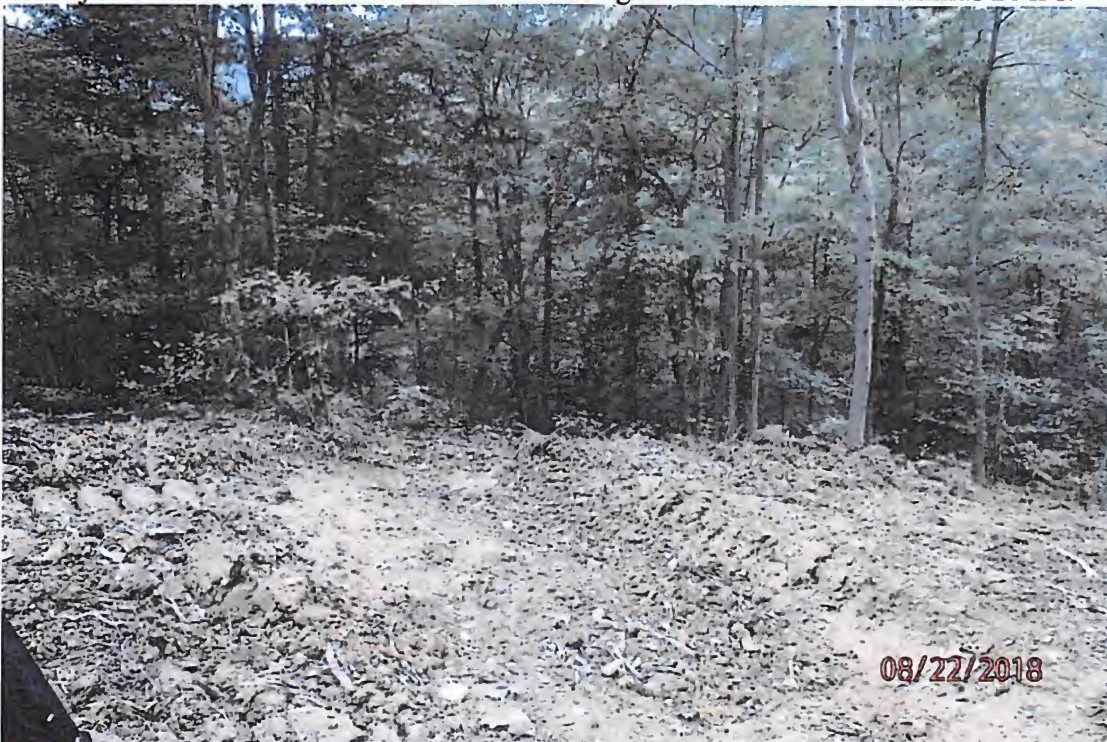
Project area on AR-10 in the Flint Run watershed showing a lack of water bar terminus BMPs.

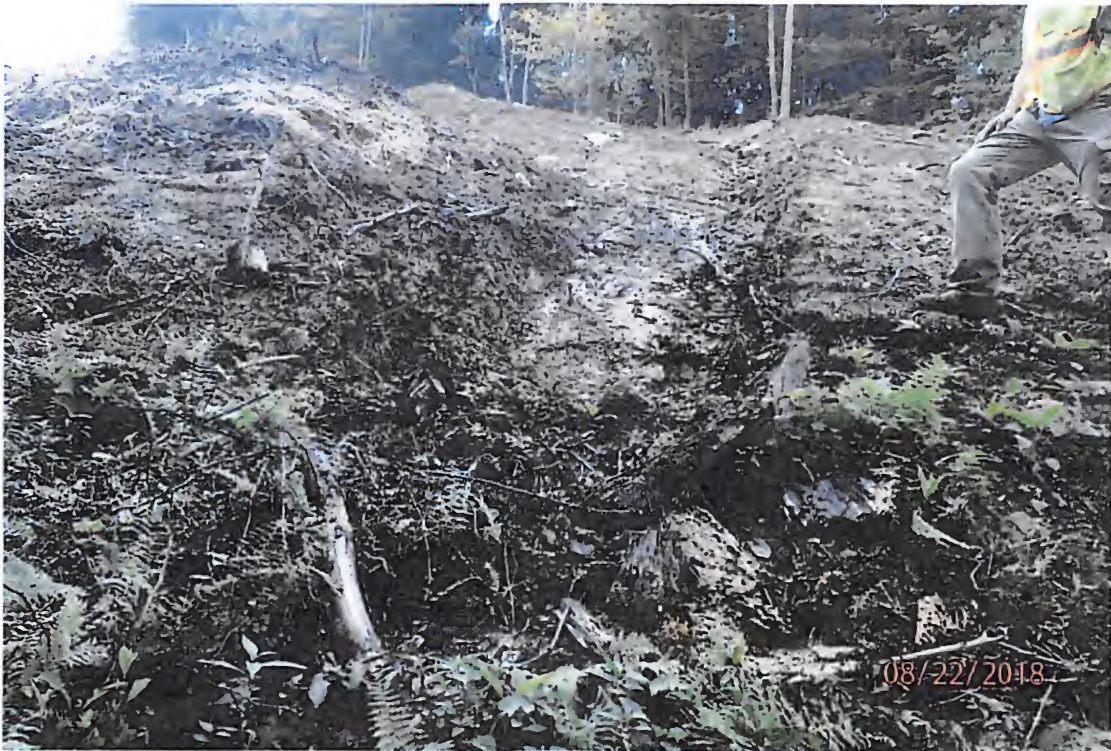
Project area in the Morgans Run watershed showing a lack of water bar terminus BMPs.

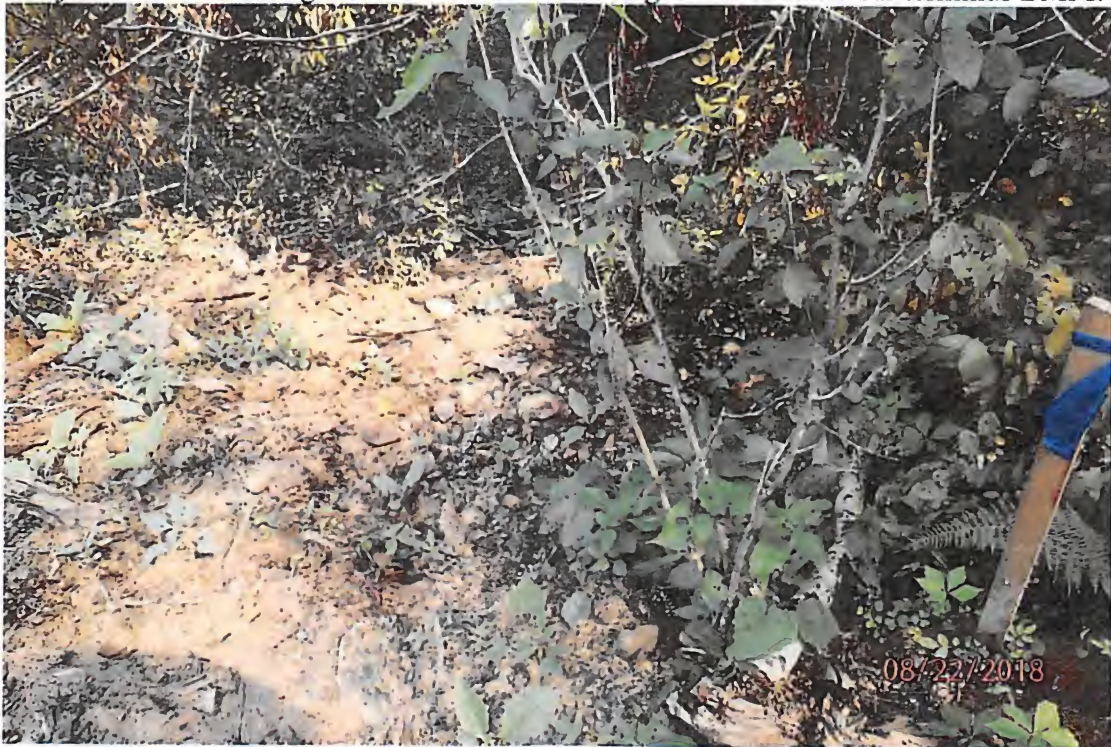
Project area in the Morgans Run watershed showing offsite deposits that lead to the receiving stream as a result of a lack of water bar terminus BMPs.

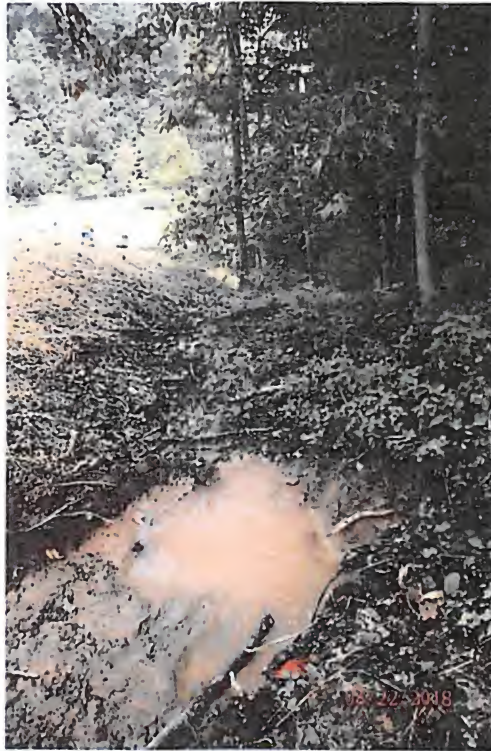
Project area in the Morgans Run watershed showing a lack of water bar terminus BMPs.

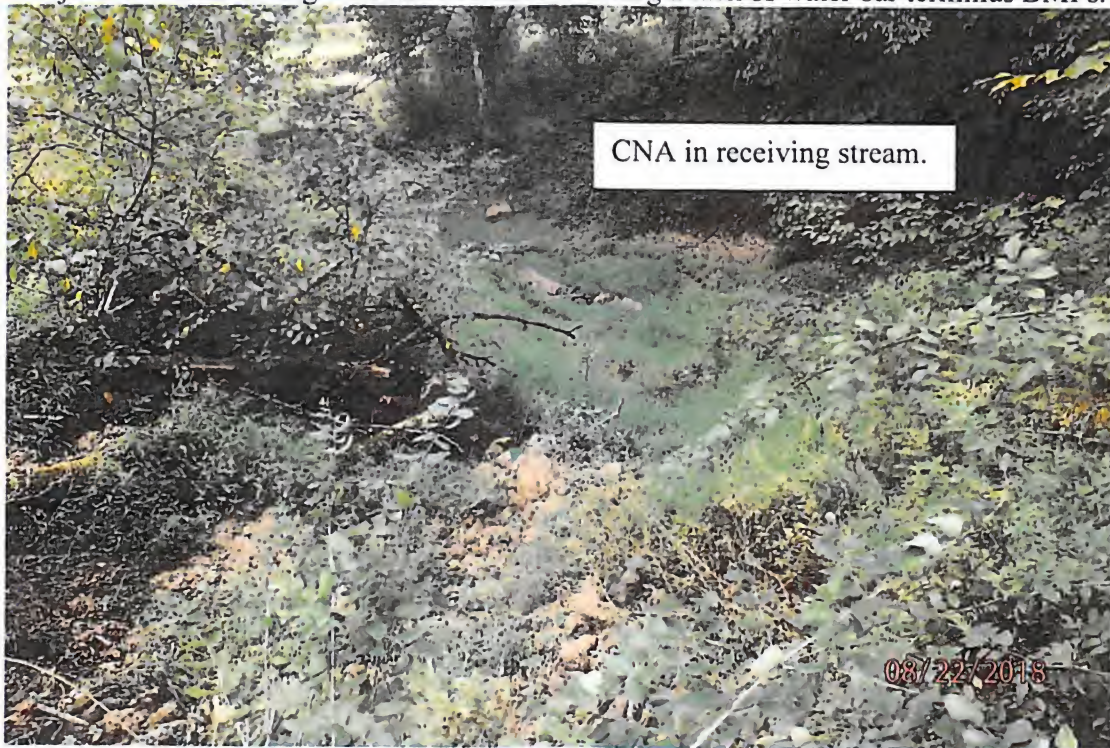
CNA deposits in UNT Morgans Run (UNT 160) ($39^{\circ} 18.488'$ X $80^{\circ} 40.335'$) as a result of a lack of installed water bar terminus BMPs.

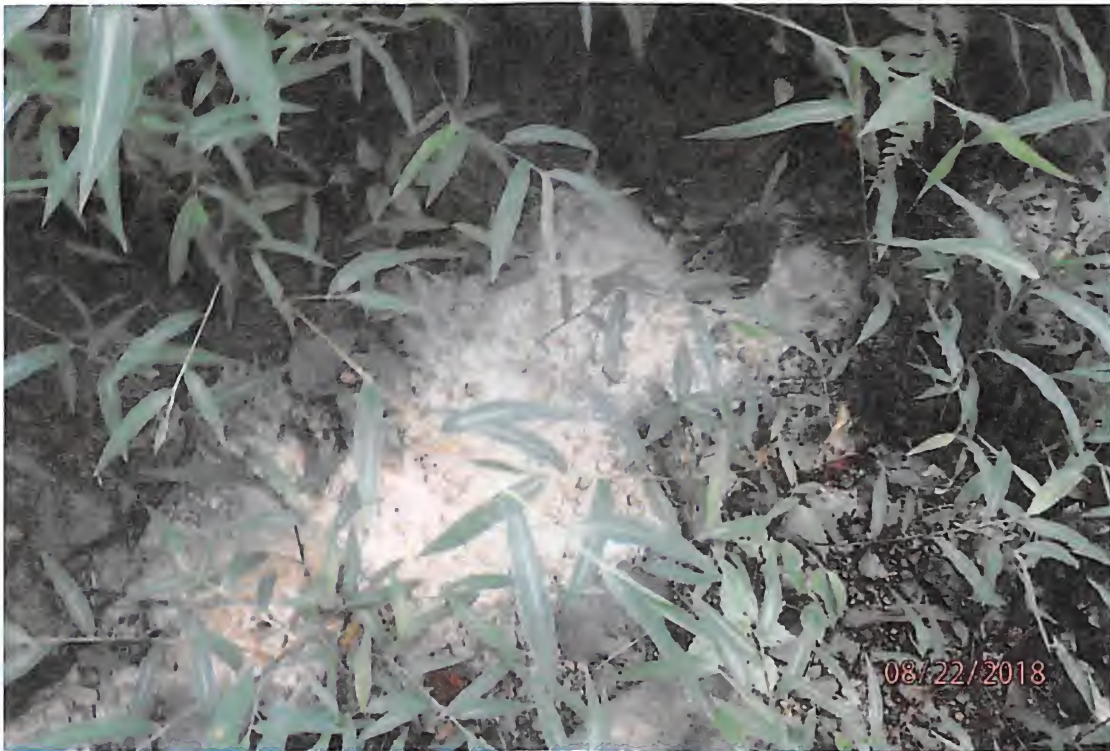
CNA deposits in UNT Morgans Run (UNT 160) ($39^{\circ} 18.488'$ X $80^{\circ} 40.335'$) as a result of a lack of installed water bar terminus BMPs

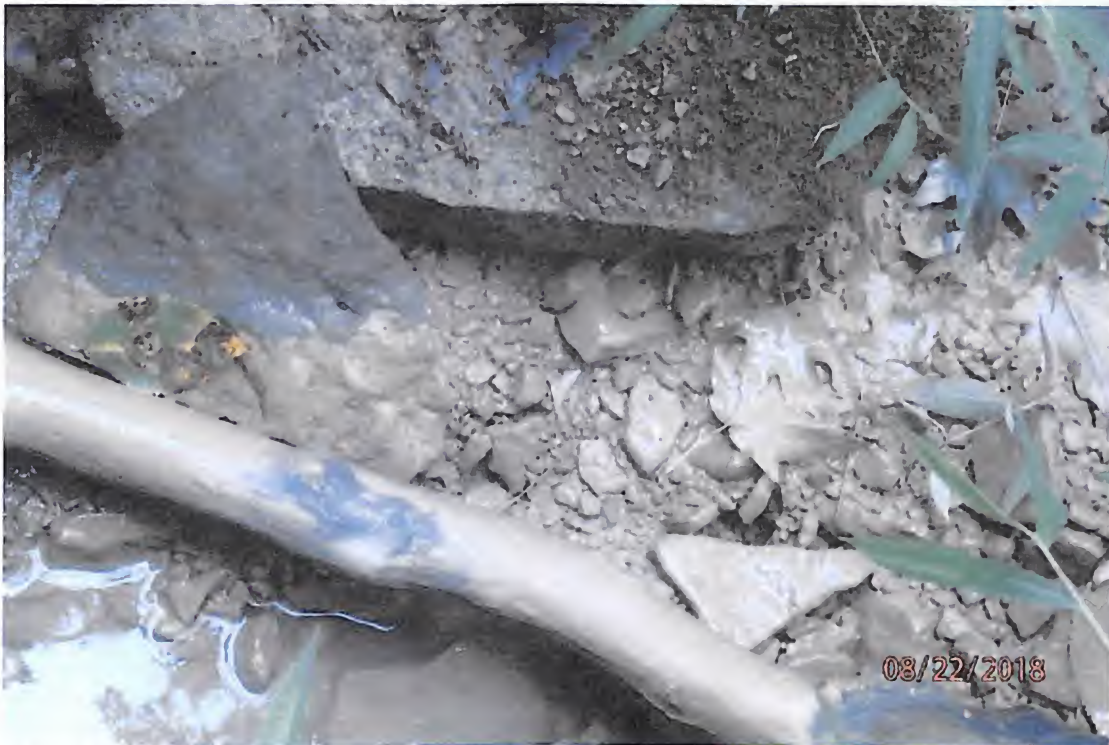
CNA deposits in UNT Morgans Run (UNT 160) ($39^{\circ} 18.488'$ X $80^{\circ} 40.335'$) as a result of a lack of installed water bar terminus BMPs.

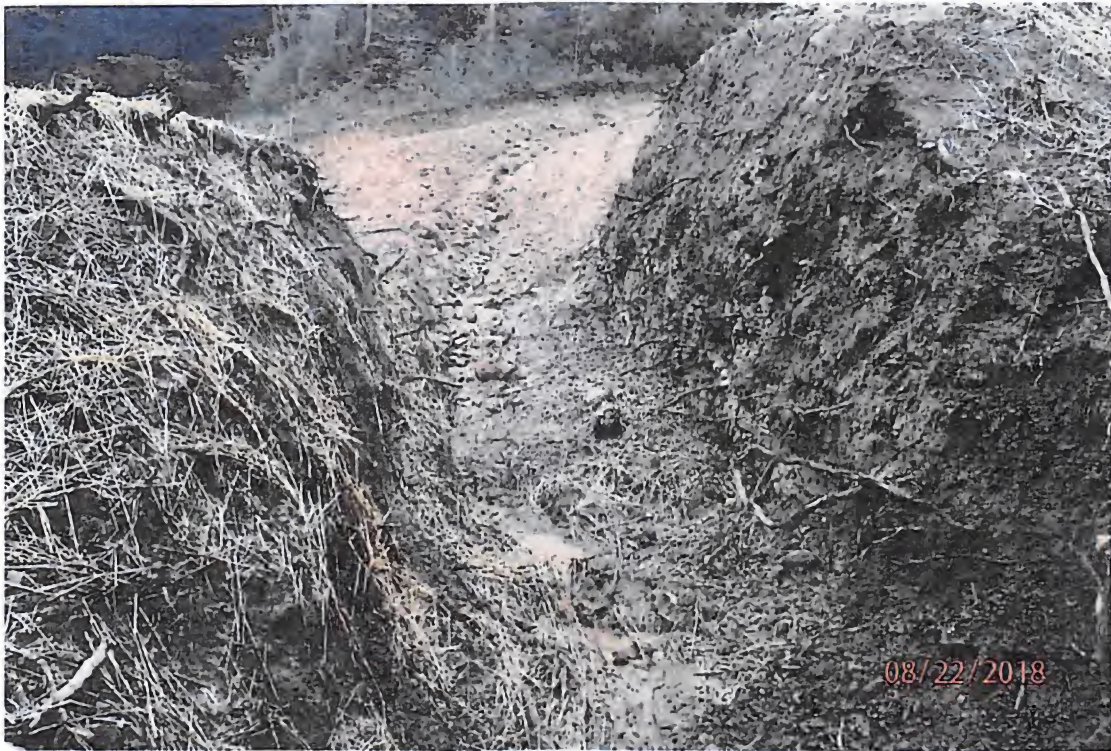
Water bar in the Morgans Run watershed that was installed at a steep angle showing erosion of the BMP.

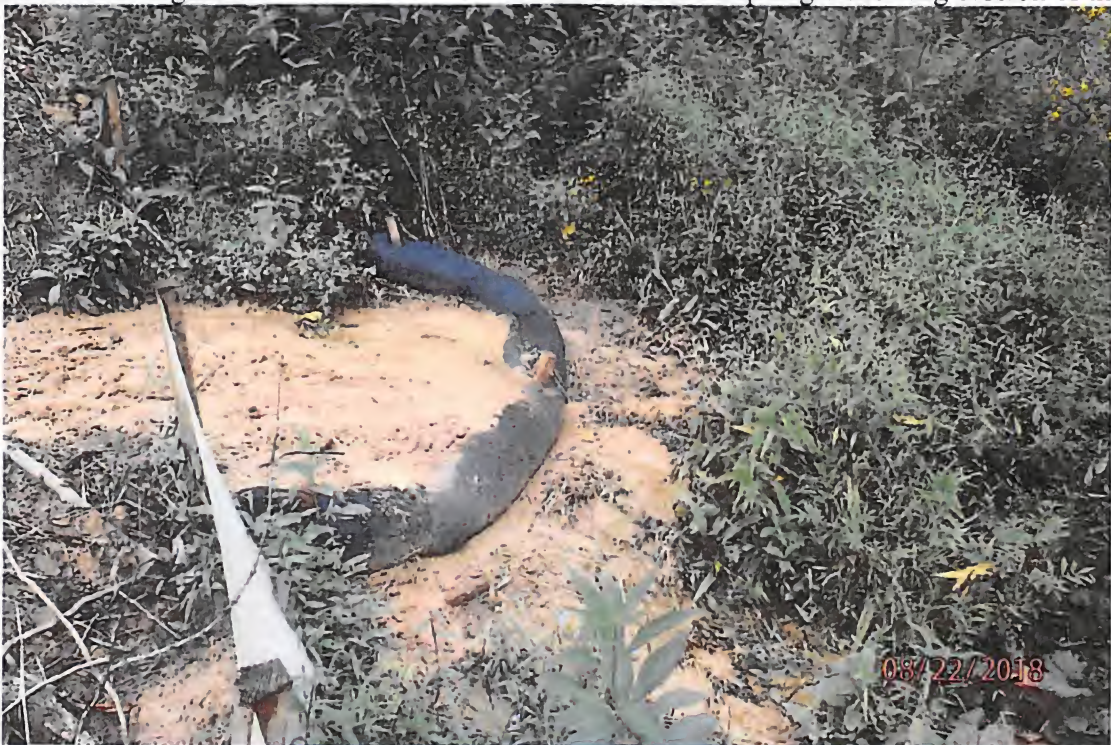
Overwhelmed water bar terminus BMP as a result of excessive erosion from the above pictured water bar.

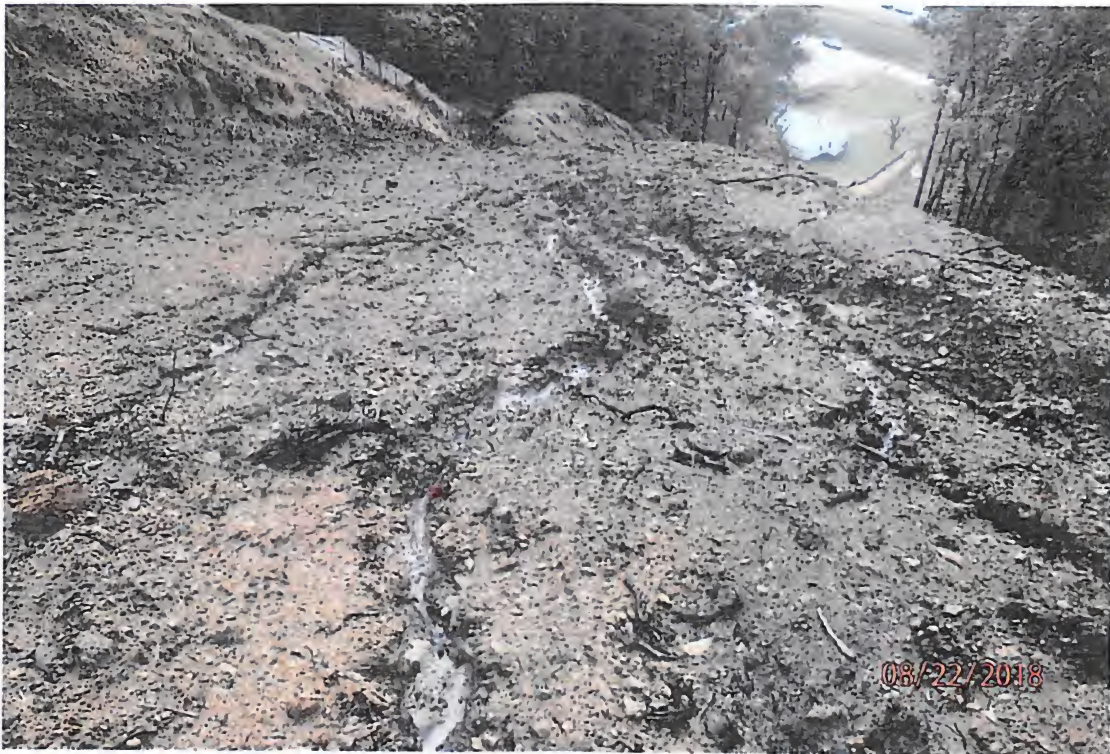
Water bar in the Morgans Run watershed that was installed at a steep angle showing erosion of the BMP.

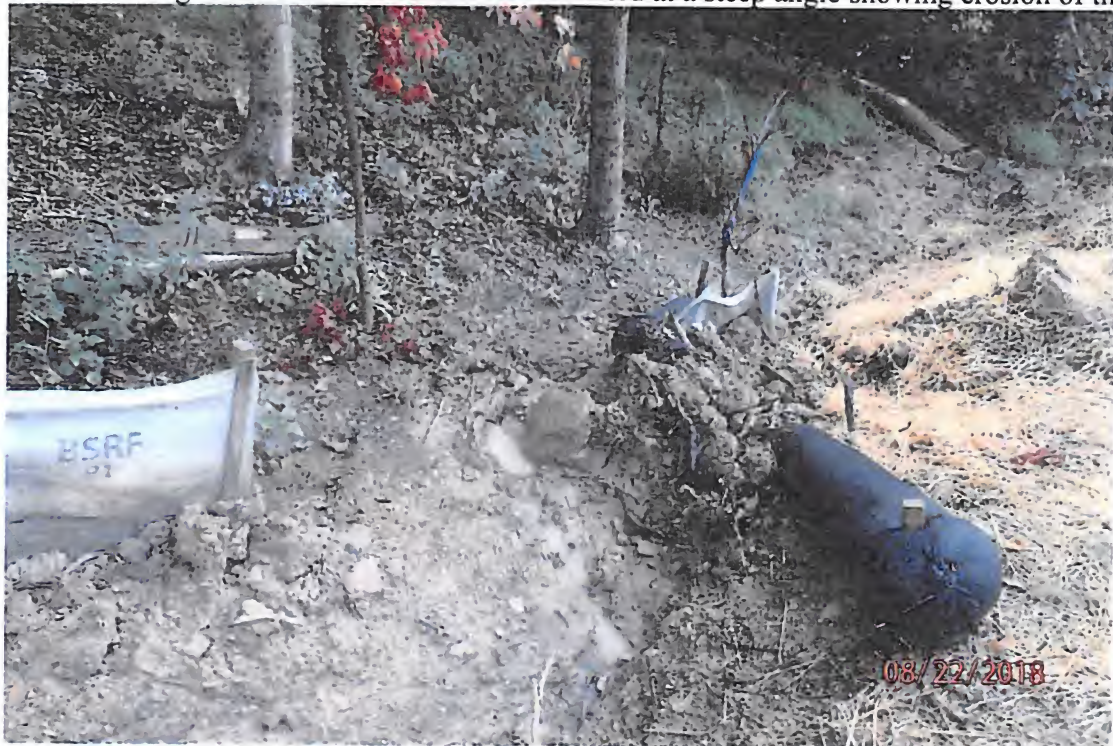
Overwhelmed water bar terminus BMP as a result of excessive erosion and increased water velocity from the above pictured water bar.

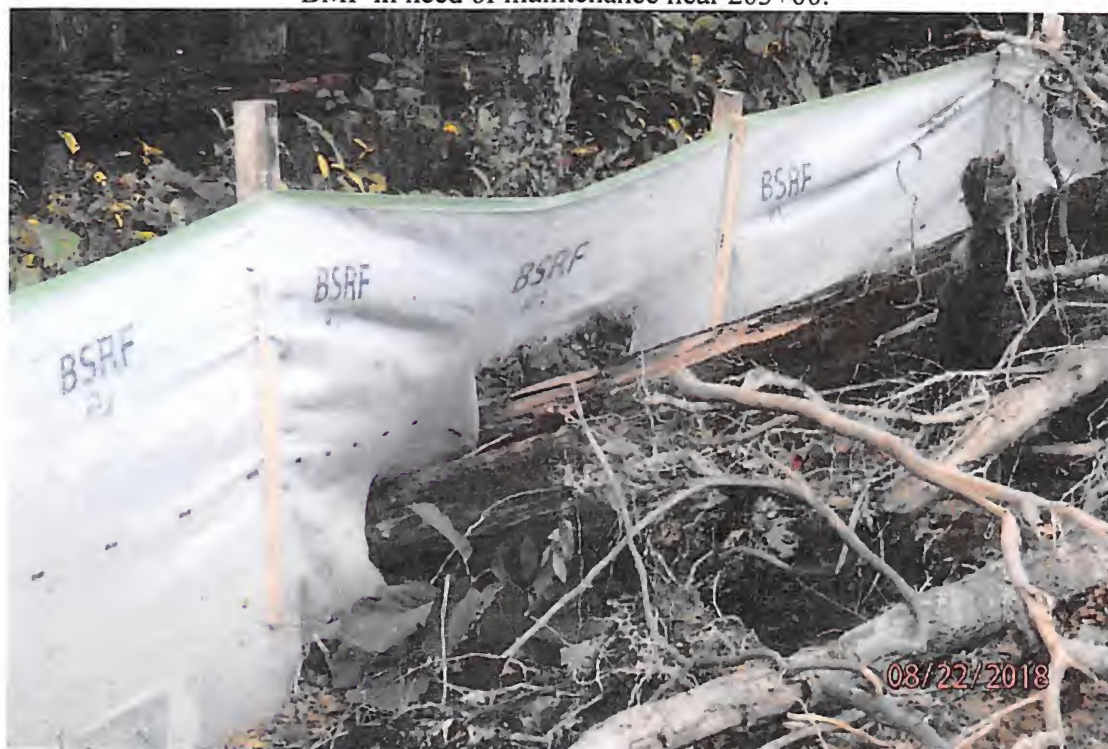
BMP in need of maintenance in the Flint Run watershed.

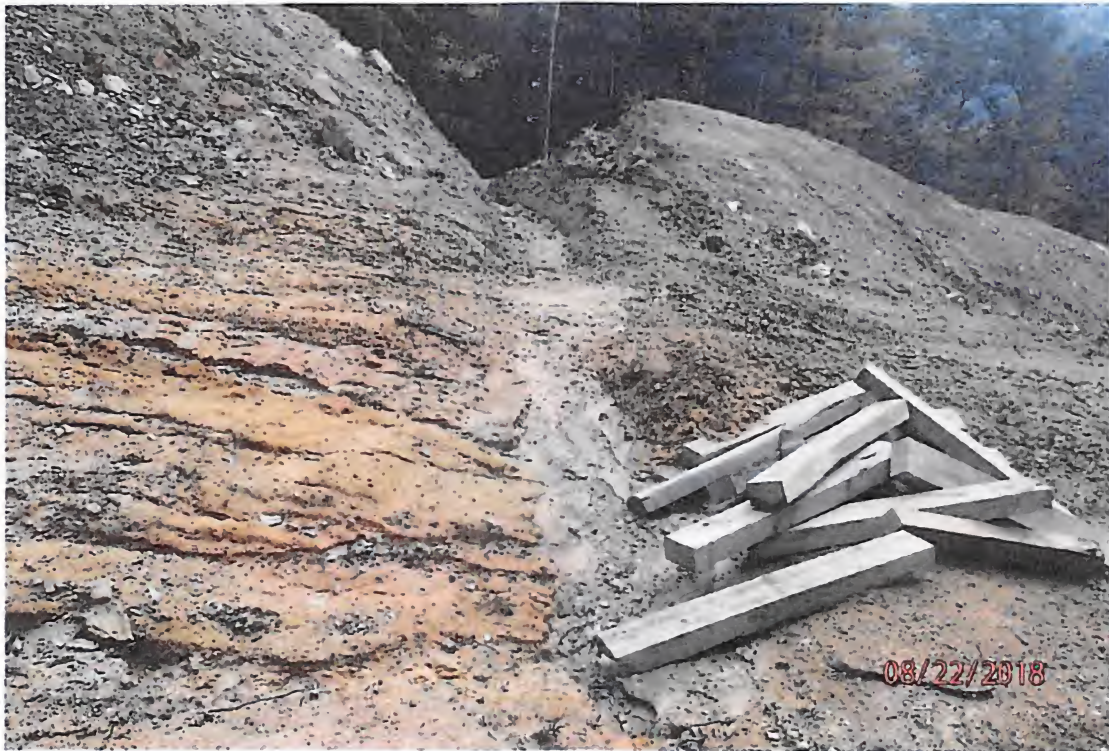
Water bar in need of maintenance in the Flint Run watershed.

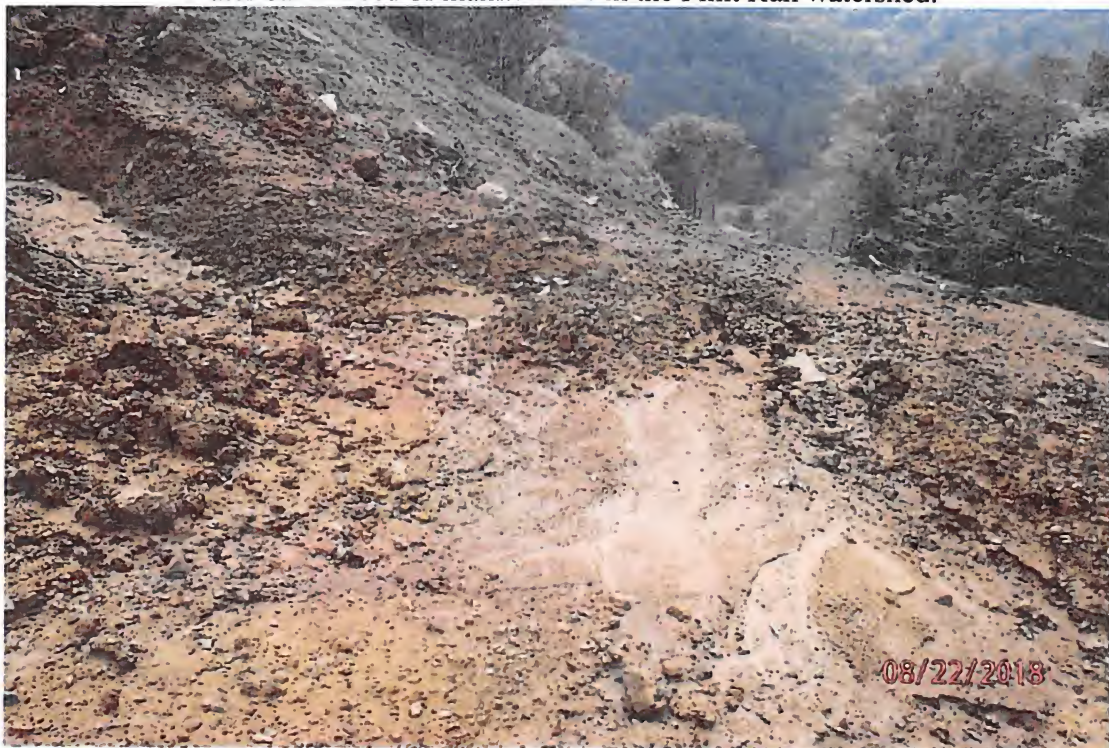
Water bar in need of maintenance in the Flint Run watershed and the associated fill slope erosion.

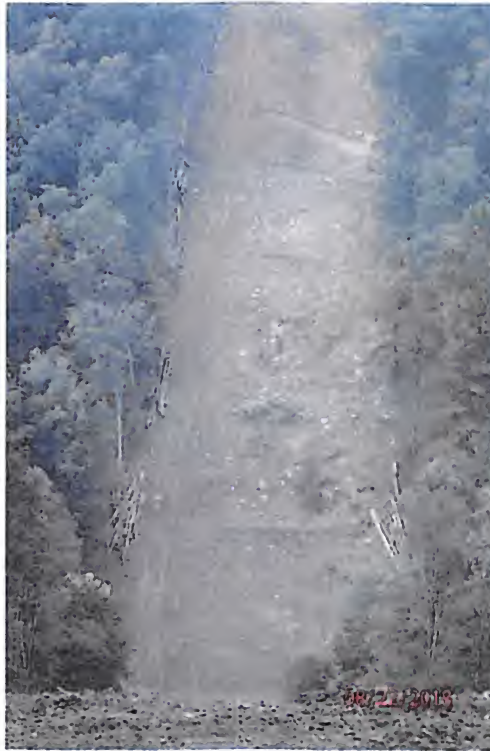
Water bars in need of maintenance (No activity for several days according to site rep.) near 437+00.

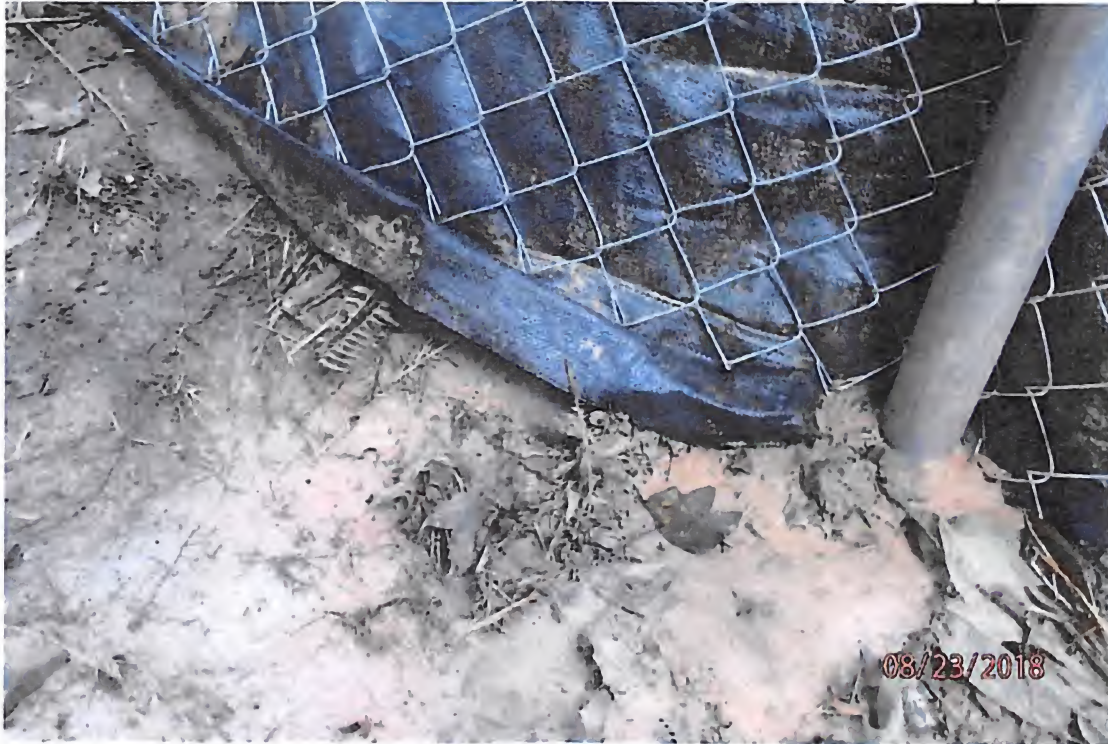
Perimeter control near 863+00 in need of maintenance.

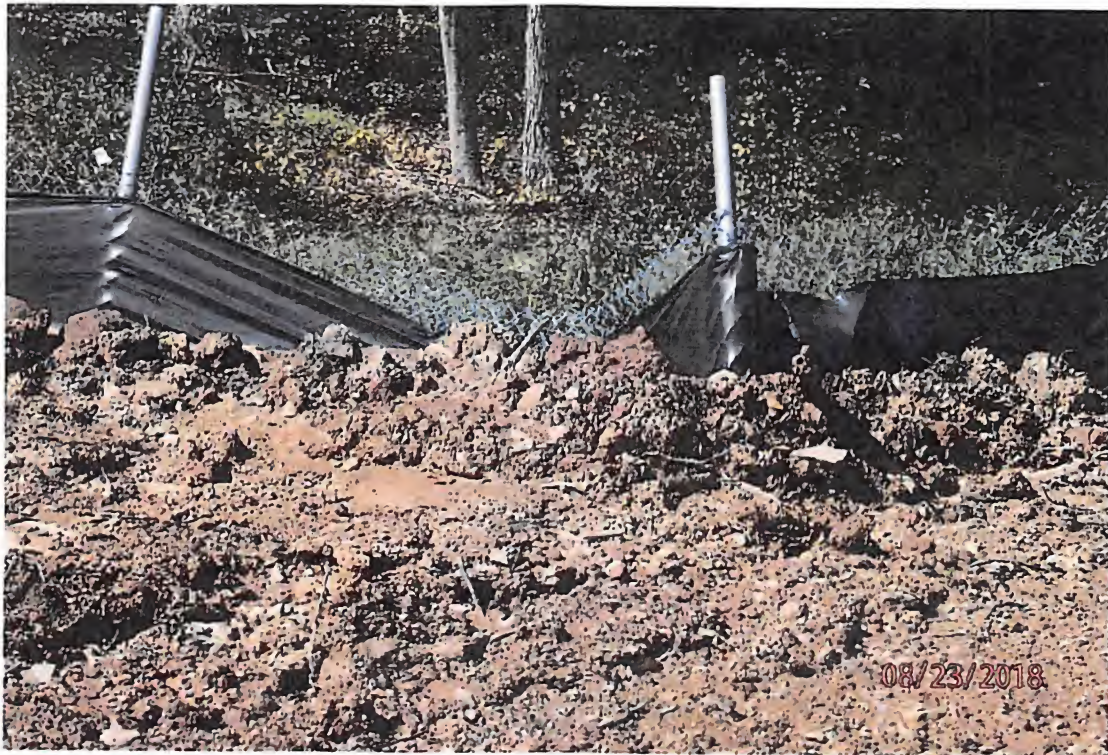
Perimeter control in need of maintenance in the Beverlin Fork watershed.

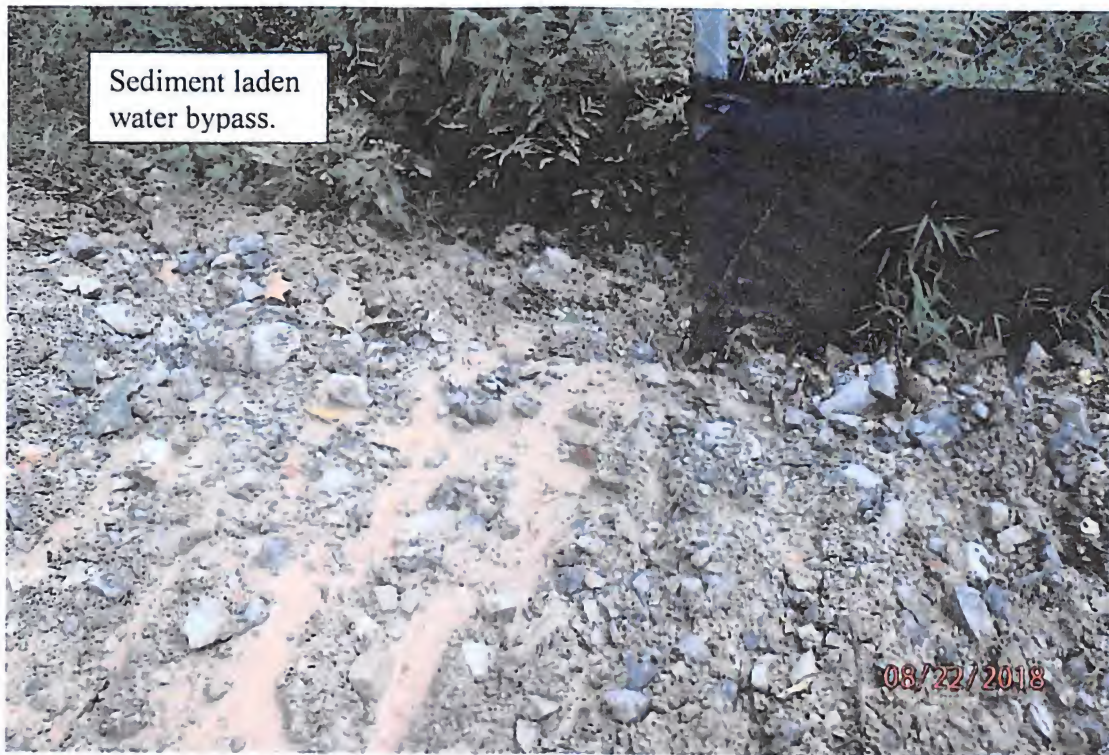
Installed perimeter control that needs to be extended adjacent to AR-2.

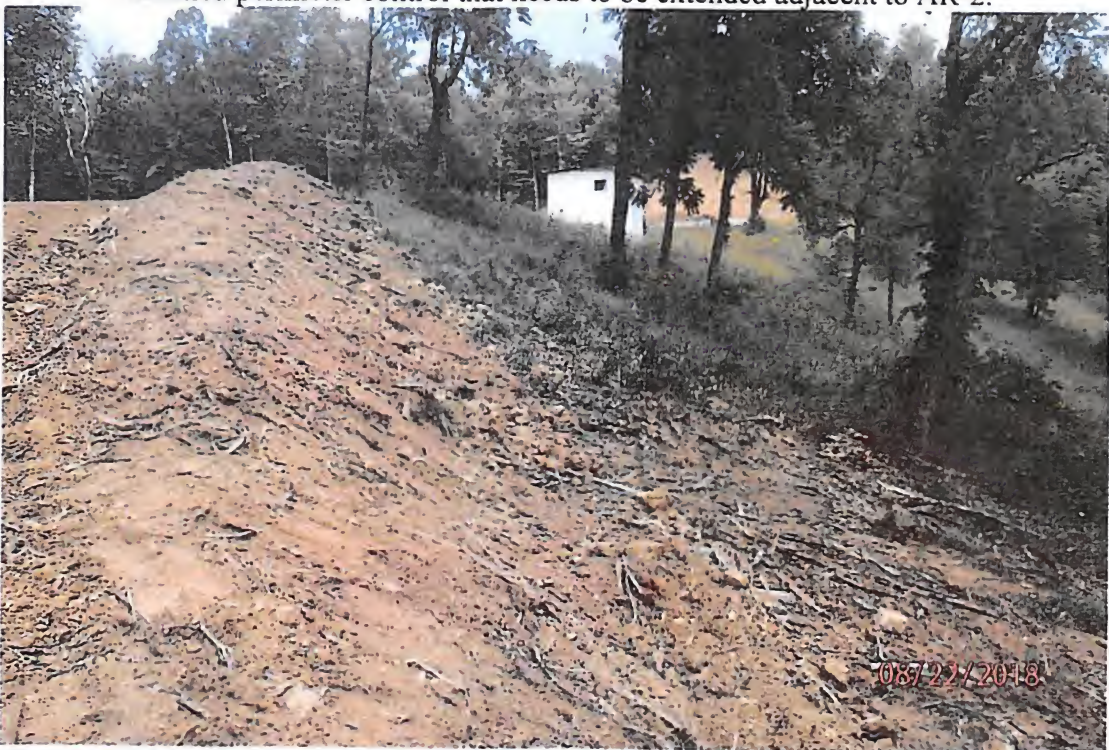
Area adjacent to 158+50 where sediment laden water is leaving the site and no BMP is indicated on the approved SWPPP.
